### Baltotopi - GREECE Flood - 30/03/2015 Delineation Map

Area of Interest 02 - Baltotopi

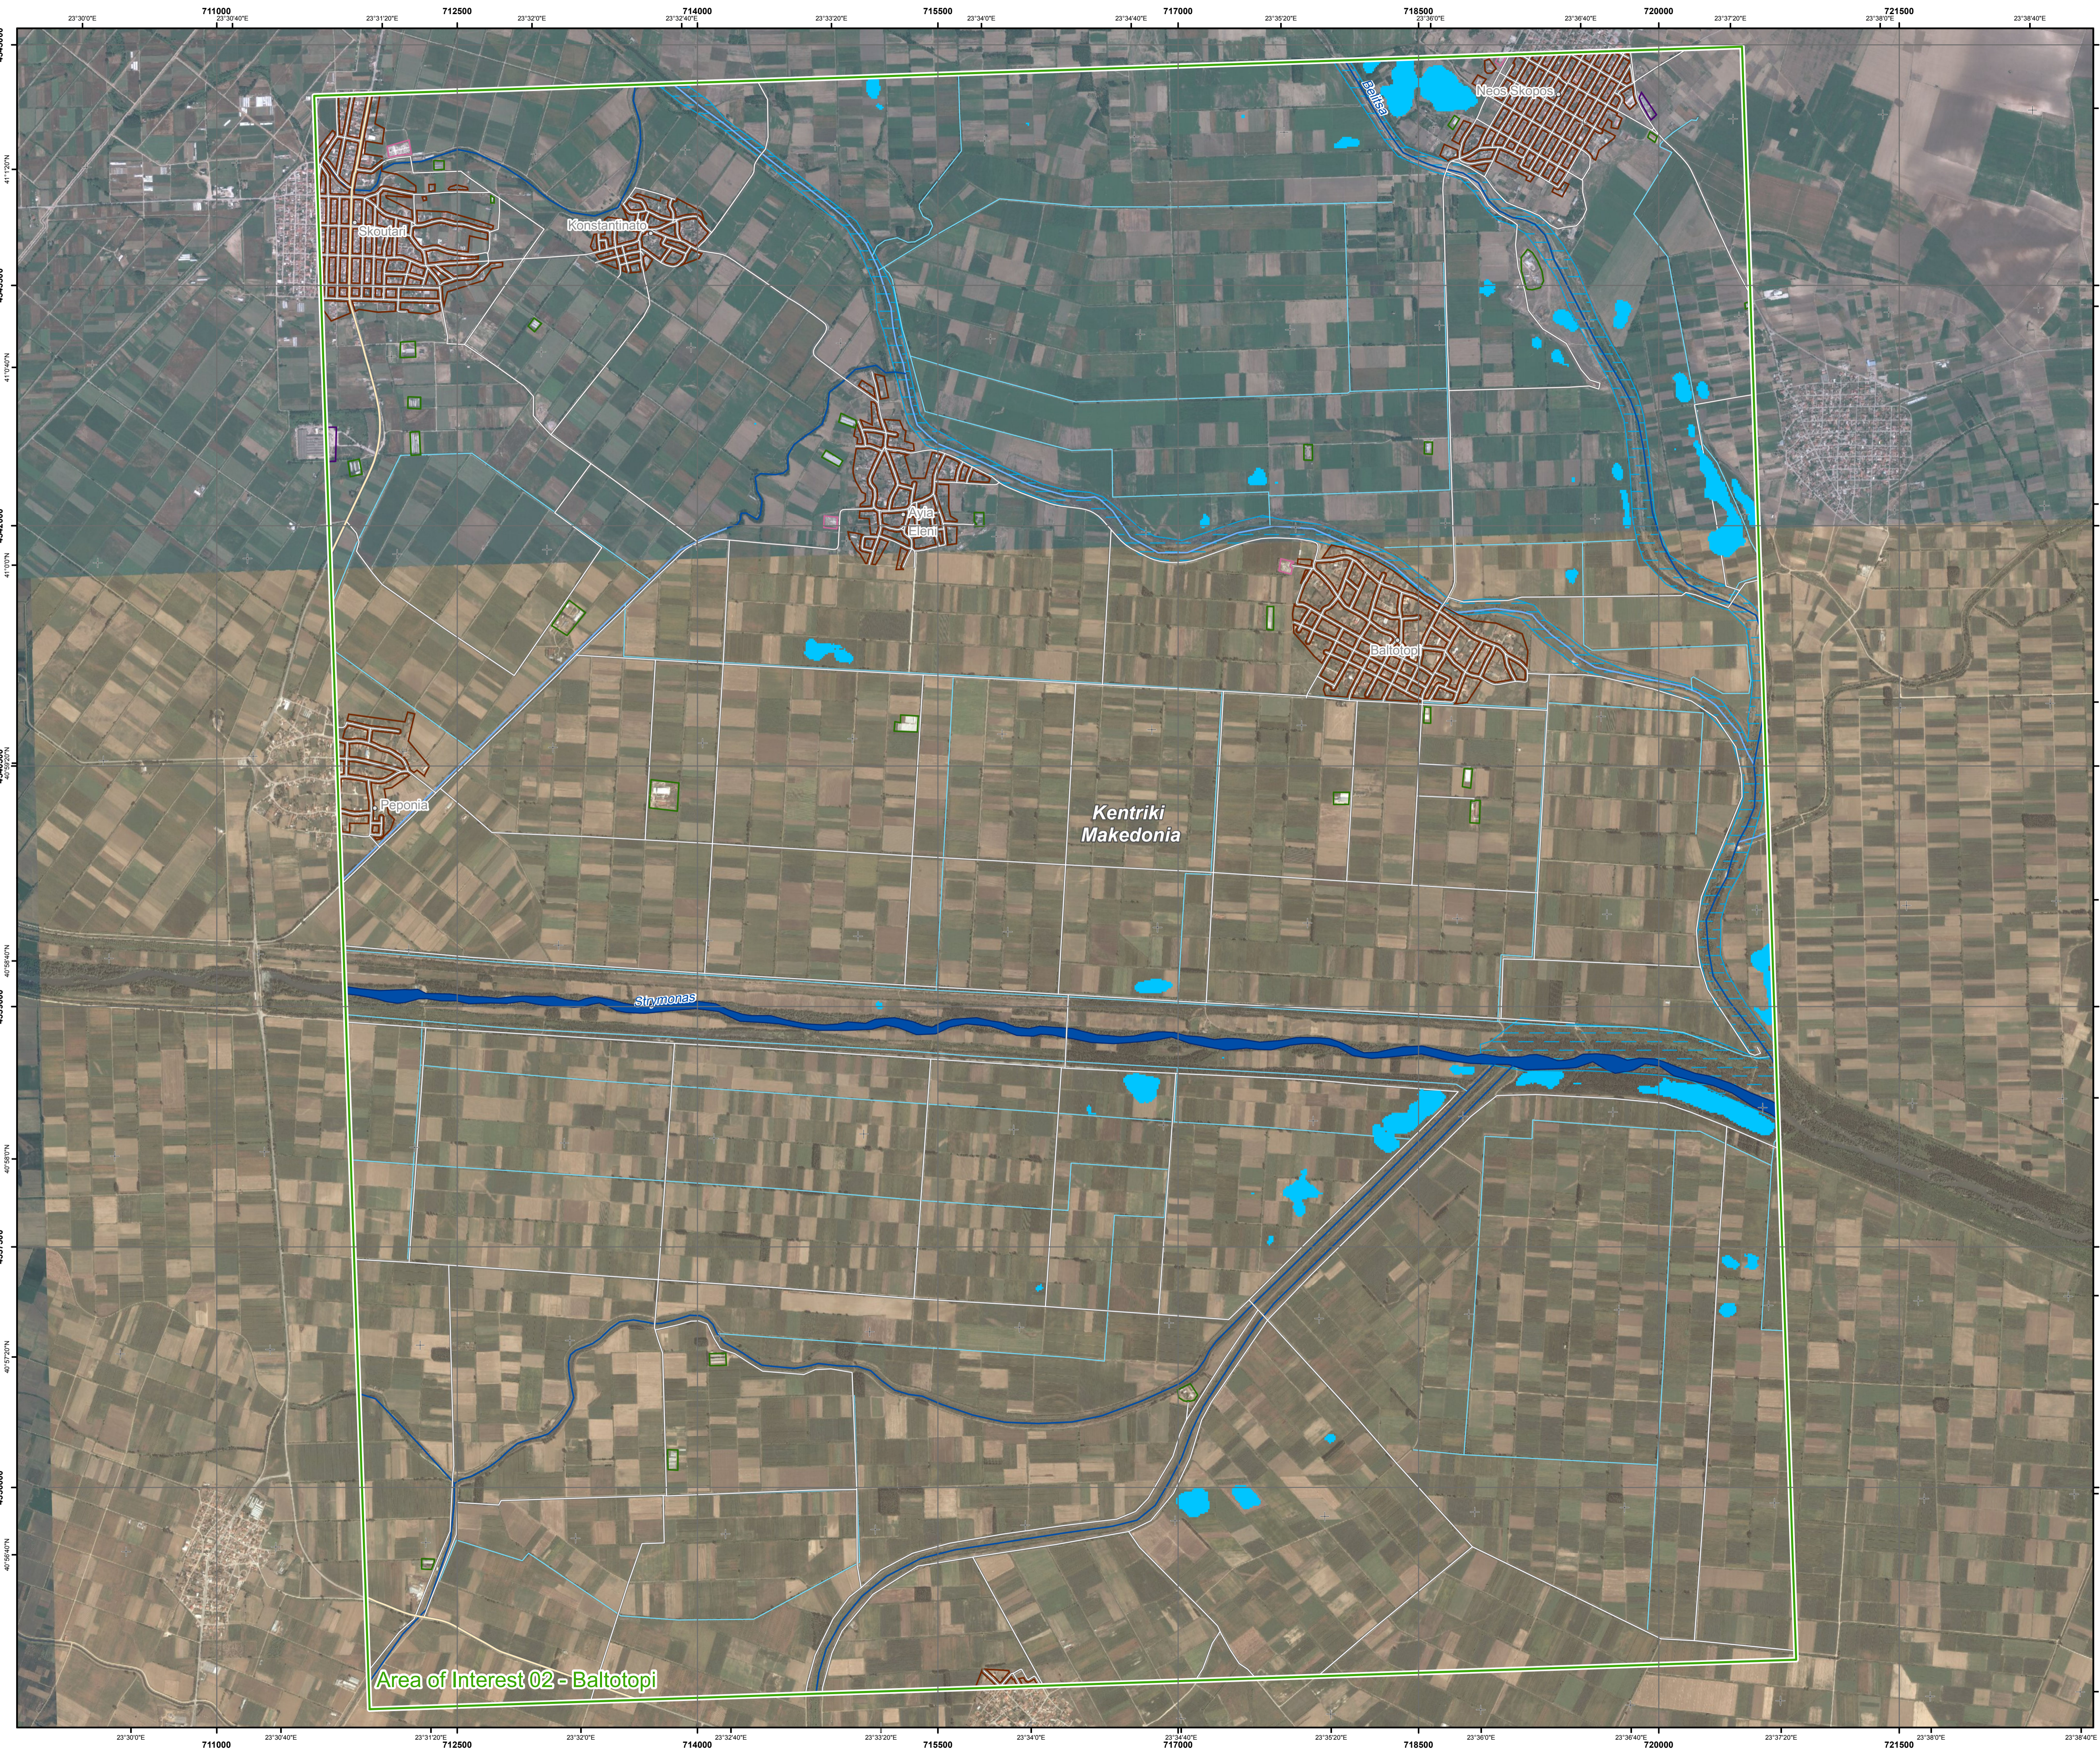
**Consequences within the AOI on 29/03/2015**

Affected	Total in AOI
Flooded area	ha	0	76.7
Estimated population	ha	0	6352
Settlements	Cemetery	ha	2.5
	Industrial	ha	1.9
	Agricultural	ha	22
	Residential	ha	207.5
Transportation	Motorways	km	37
	Local roads	km	6.2

**Map Information**  
 Due to heavy rainfall during last month, extensive damages have been reported in infrastructures and networks along the Stymonas river, in Central Macedonia. Many embankments have been broken, especially in the southern part of the river, flooding the road and rural network, while many hectares of agricultural land have been completely inundated. The affected areas were declared in the state of emergency. The core users of the maps are Disaster Response Authorities involved in the operations.

**Map Production**  
 The present map shows basic topographic features such as transportation, hydrology, settlements, industry and utilities in the area of Baltotopi (GREECE). The layer 'Land subject to inundation' includes areas such as riverbed, river meadow and marsh. These basic topographic features are derived from public datasets, refined by means of visual interpretation of post-event Sentinel-1A images.  
 All satellite images have been radiometrically enhanced, orthorectified with RPC approach (using SRTM elevation data) and coregistered to the pre-event image.  
 The estimated geometric accuracy of this product is 5 m CE90 or better, from native positional accuracy of the background satellite image.  
 The estimated thematic accuracy of this product is 85% or better, as it is based on visual interpretation of recognizable items on very high resolution optical imagery. Shadowed areas are zones of lower interpretation accuracy due to the poorer image radiometry.
