### Strymonas River - GREECE Flood - 30/03/2015 Delineation Map - Monit 02

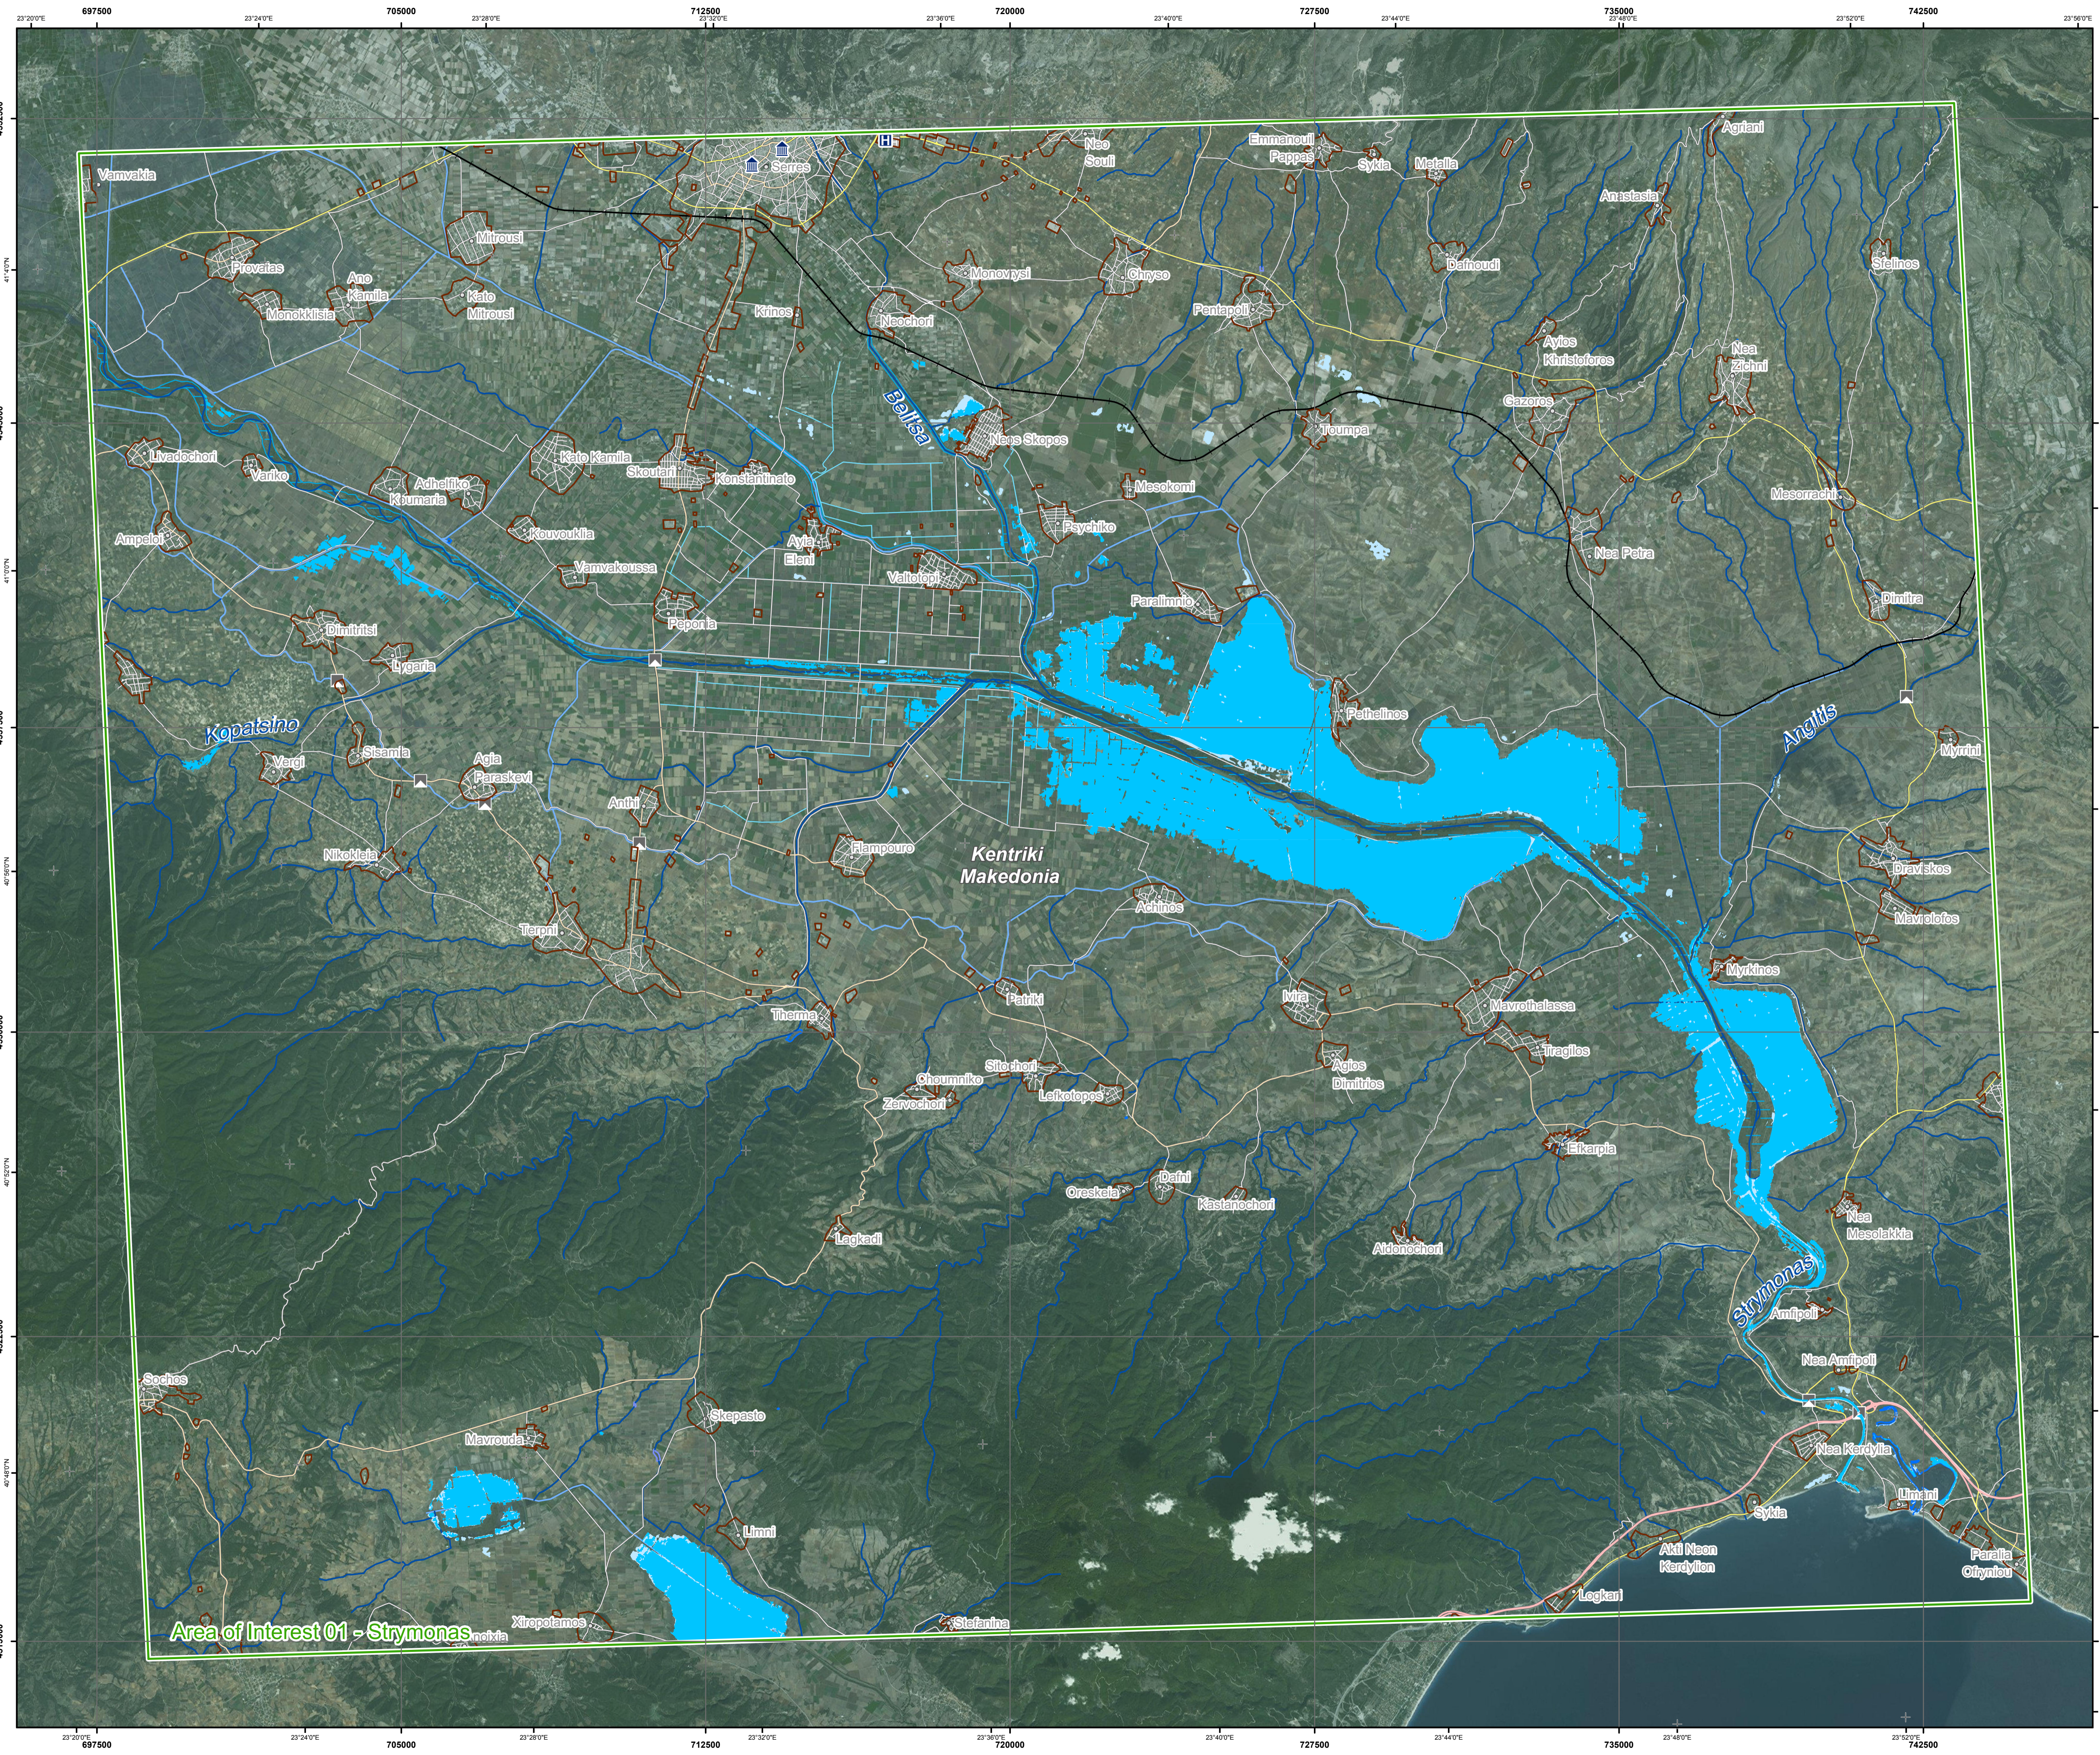
Due to heavy rainfall during last month, extensive damages have been reported in infrastructures and networks along the Strymonas river, in Central Macedonia. Many embankments have been broken, especially in the southern part of the river, flooding the road and rural network, while many hectares of agricultural land have been completely inundated. The affected areas were declared in the state of emergency. The core users of the maps are Disaster Response Authorities involved in the operations.

The present map shows the flood delineation in the area in the area of Strymonas (GREECE). The basic topographic features are derived from public datasets, refined by means of visual interpretation of the pre-event ESRI World Imagery. The layer 'Land subject to inundation' includes areas such as riverbed, river meadow and marsh. Thematic layers, assessing the delineation of the event, have been derived from the postevent COSMO-SkyMed and Sentinel-1 A images.  
 All satellite images have been radiometrically enhanced, orthorectified with RPC approach (using SRTM elevation data) and coregistered to the pre-event image.  
 The estimated geometric accuracy of this product is 5 m CE90 or better, from native positional accuracy of the background satellite image.  
 The estimated thematic accuracy of this product is 85% or better, as it is based on visual interpretation of recognizable items on very high resolution optical imagery. Shadowed areas are zones of lower interpretation accuracy due to the poorer image radiometry. Only the area enclosed by the Area of Interest has been analyzed.
