Strymonas River - GREECE Flood - 30/03/2015 Delineation Map

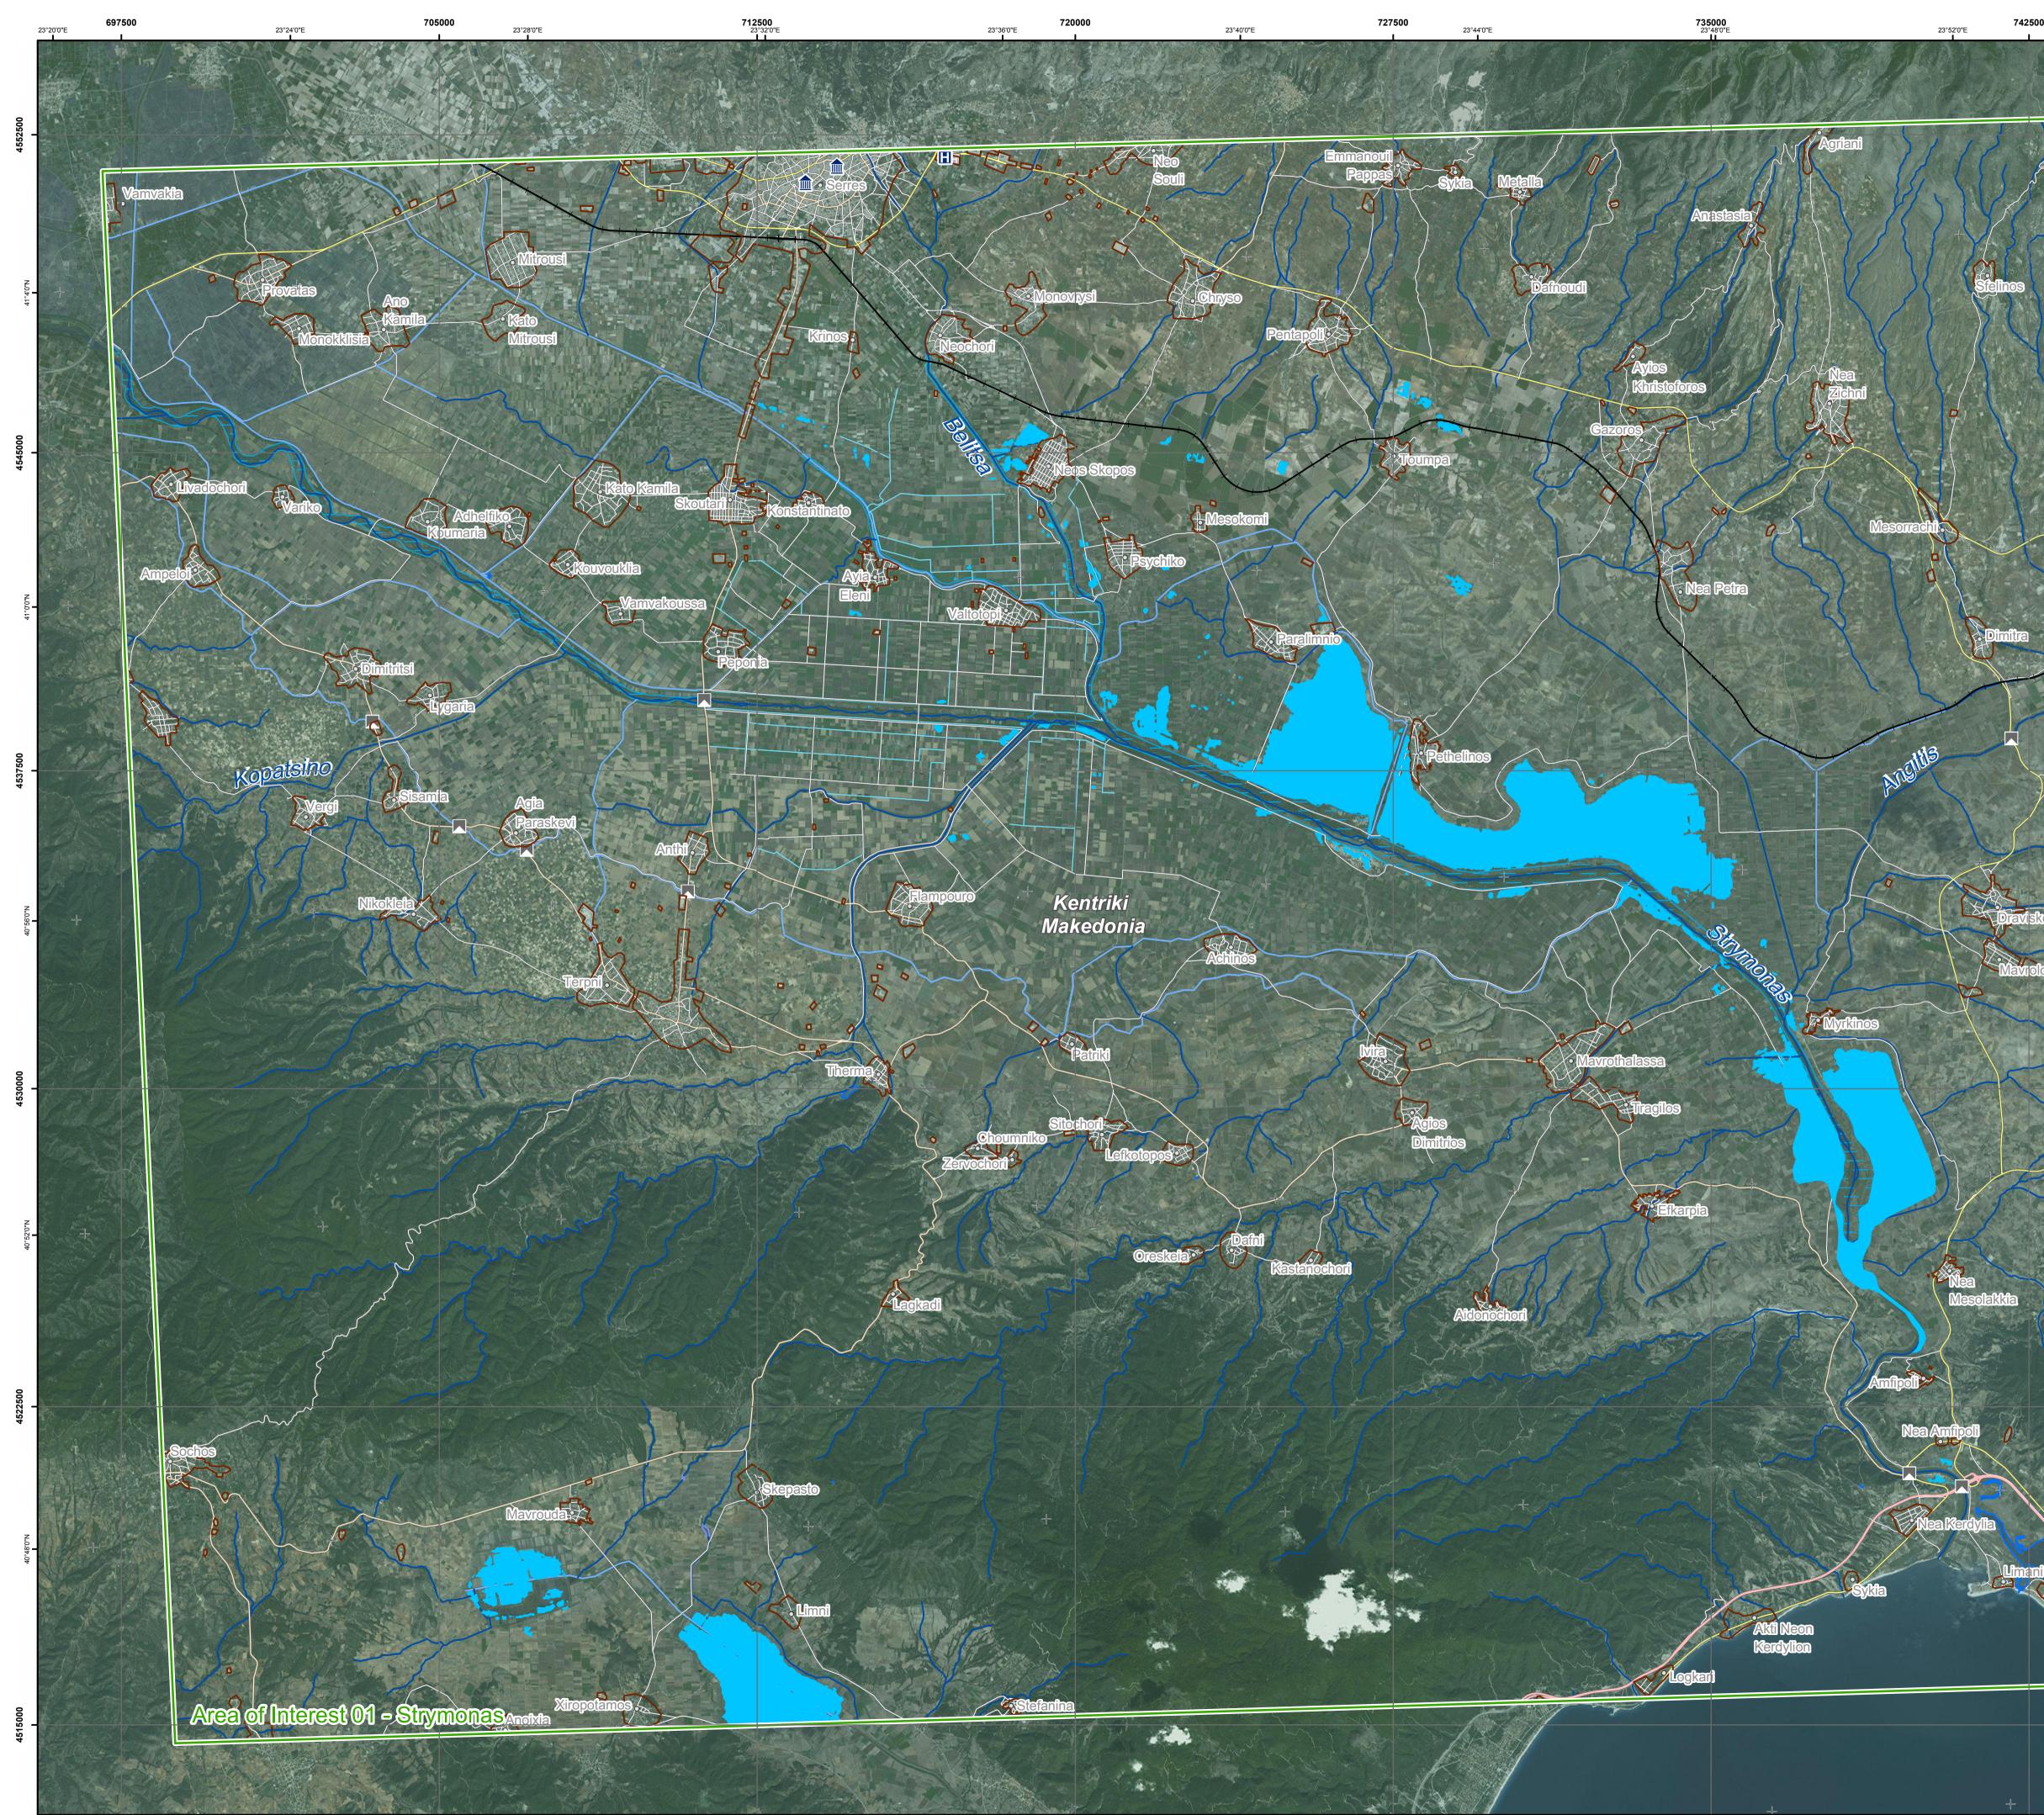
Consequences within t	he AOI on 29/03/20	15			
			Affected	Total in AOI	
Flooded area		ha		4503	
Estimated population		Inhabitants	107	107933	
Settlements	Build-Up Area	ha	0.1	7951	
Transportation	Motorways	km	0	37	
	Primary roads	km	0	107	
	Local roads	km	6.2	1092

The present map shows the flood delineation in the area in the area of Strymonas (GREECE). The basic topographic features are derived from public datasets, refined by means of visual interpretation of the pre-event ESRI World Imagery. The layer 'Land subject to inundation' includes areas such as riverbed, river meadow and marsh.Thematic layers,

to infundation includes areas such as riverbed, river meadow and marsh. I nematic layers, assessing the delineation of the event, have been derived from the postevent and Sentinel-1 A image. All satellite images have been radiometrically enhanced, orthocorrected with RPC approach (using SRTM elevation data) and coregistered to the pre-event image. The estimated geometric accuracy of this product is 5 m CE90 or better, from native positional accuracy of the background extilite image. positional accuracy of the background satellite image.

The estimated thematic accuracy of this product is 85% or better, as it is based on visual interpretation of recognizable items on very high resolution optical imagery. Shadowed areas are zones of lower interpretation accuracy due to the poorer image radiometry. Only the area enclosed by the Area of Interest has been analyzed

Due to heavy rainfall during last month, extensive damages have been reported in infrastructures and networks along the Strymonas river, in Central Macedonia. Many embankments have been broken, especially in the southern part of the river, flooding the road and rural network, while many hectares of agricultural land have been completely inundated. The affected areas were declared in the state of emergency. The core users of the maps are Disaster Response Authorities involved in the operations.
